# 1. INVENTORY AND FACILITY REQUIREMENTS FINAL

The purpose of this chapter is to establish existing conditions at the Central Wisconsin Airport (CWA or the Airport) to serve as a baseline for the Terminal Area Master Plan (TAMP or the Master Plan). This chapter will also evaluate the existing facilities to determine their ability to meet forecasted activity and demand as well as Federal Aviation Administration (FAA) design standards. The forecast for TAMP can be found in **Appendix A**.

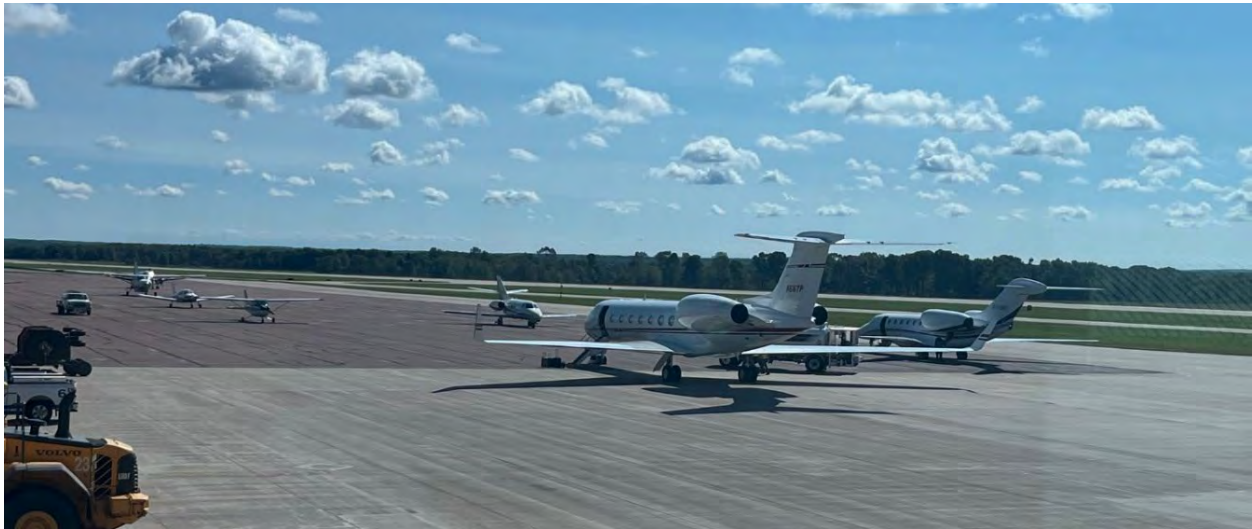
Image 1-1 Corporate Jet Parked on Concrete Apron

For orientation, this image was photographed from the passenger terminal and is facing east. This image depicts a corporate jet parked on the concrete in front of the ARFF/SRE building interrupting activity coming in and out of the building. As mentioned above, larger corporate jets are too heavy to park on asphalt; therefore, parking this aircraft on the asphalt will deteriorate the pavement.

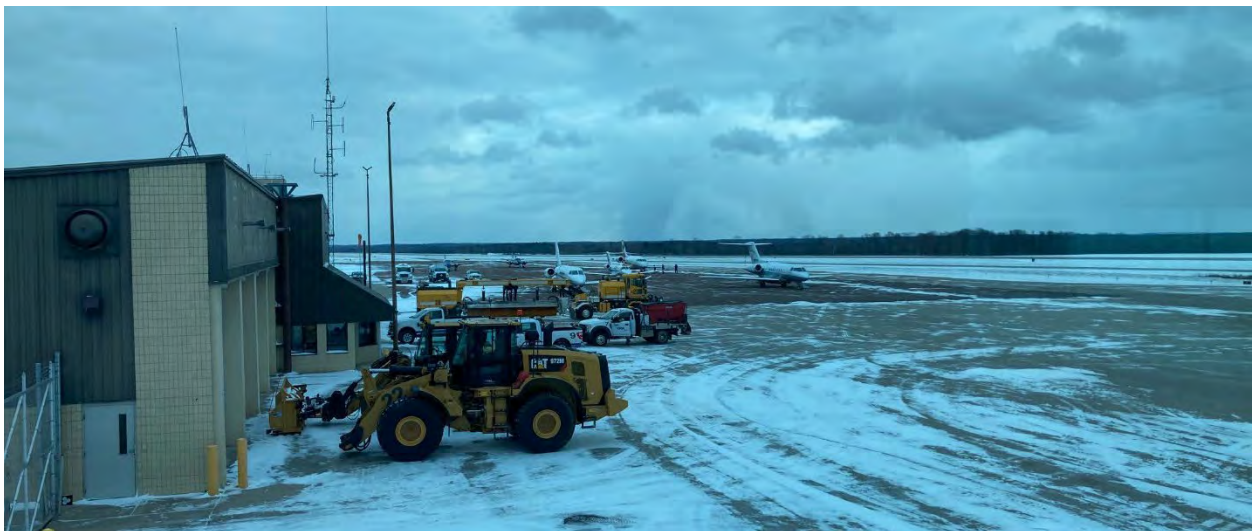
Image 1-2 Corporate Jet Parked on Asphalt Apron

For orientation, this image was photographed from the passenger terminal and is facing east. This image captures a time where SRE vehicles are parked in front of the ARFF/SRE building forcing corporate jets to park on the asphalt apron. The pavement was not designed to support these loads which can lead to pavement structure issues.

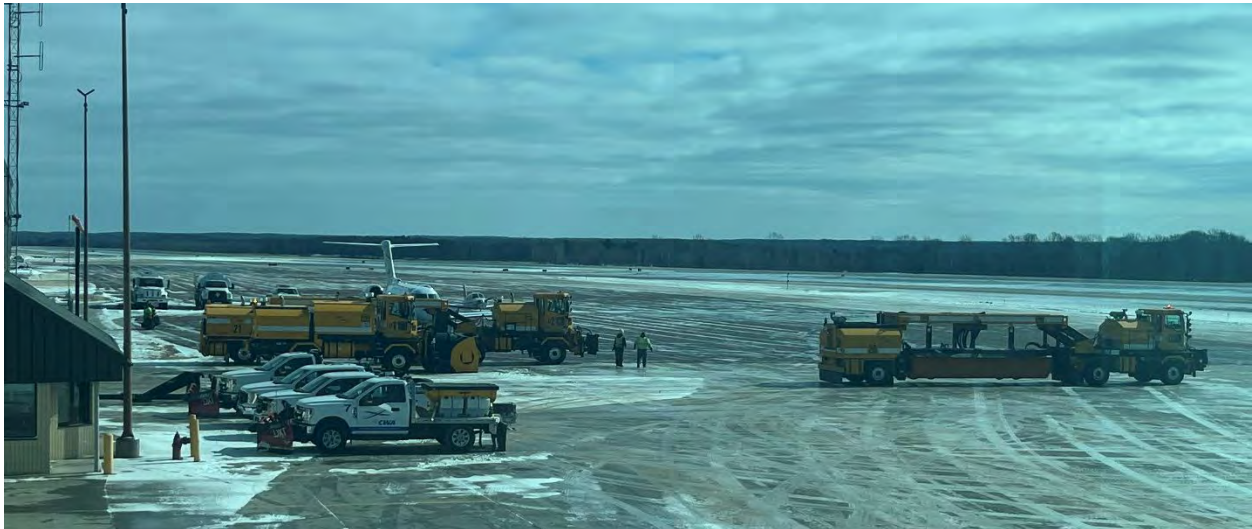
Image 1-3 Corporate Jet Parked on Asphalt Apron

For orientation, this image was photographed from the passenger terminal and is facing east. Similar to Image 1-2, this image captures a different day where SRE vehicles parked in front of the ARFF/SRE building and a corporate jet can be seen parked on the asphalt behind the SRE vehicles.

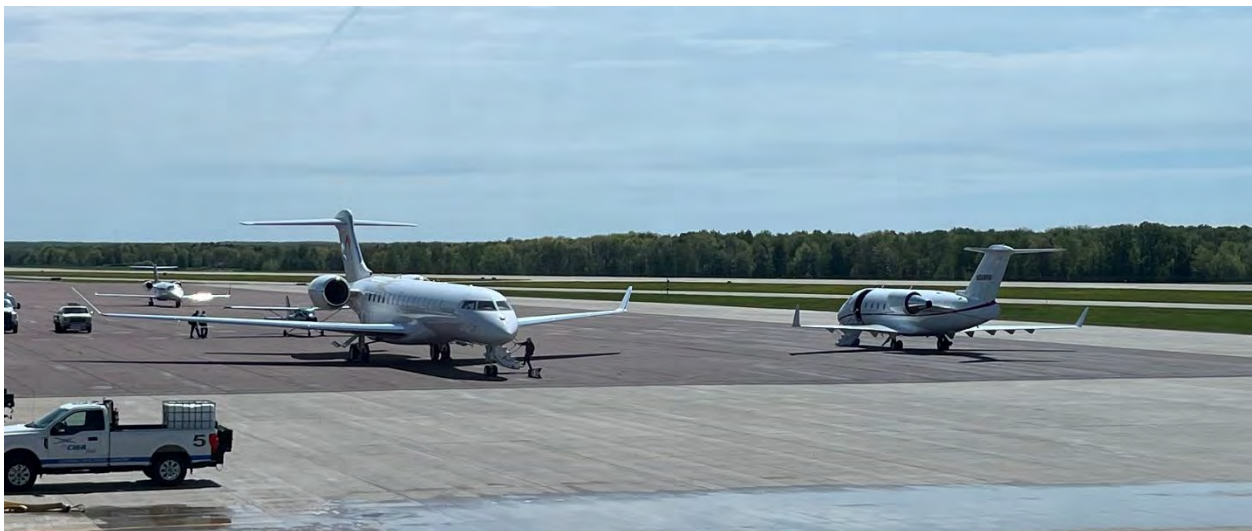
Image 1-4 Corporate Jet Parked on Asphalt Apron

For orientation, this image was photographed from the passenger terminal and is facing east. This image captures a corporate jet parked on the asphalt. A corporate jet of that size typically parks on the concrete adjacent to the GA apron; however, given that there is liquid on the concrete, it appears as if some other vehicle or equipment was using that space prior to the corporate jet arriving to the apron. That is likely the reason the jet is parked on the asphalt rather than the concrete.

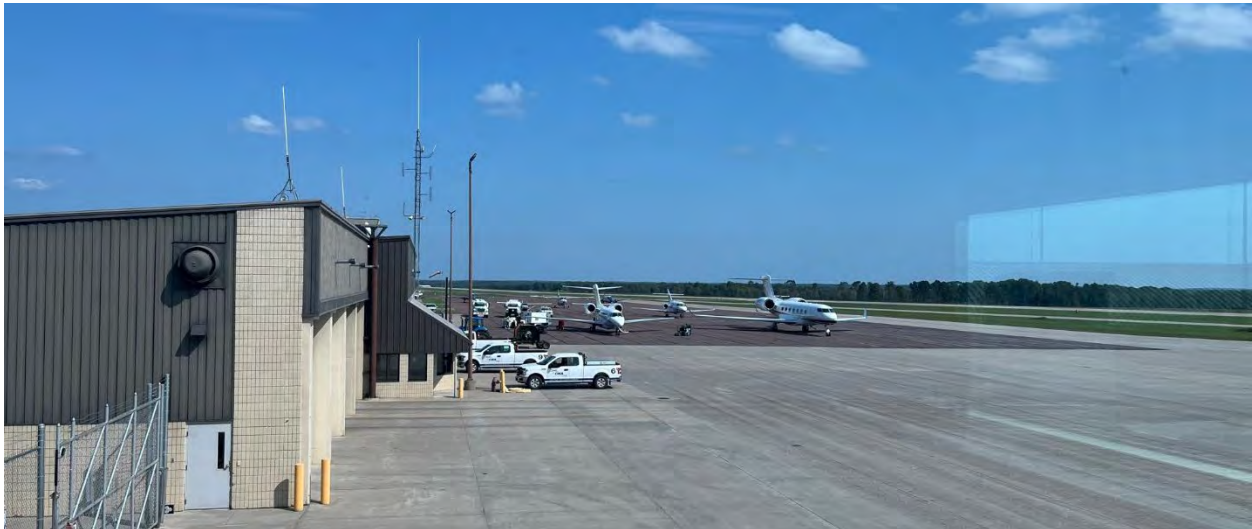
Image 1-5 Jets Parked Side by Side

For orientation, this image was photographed from the passenger terminal and is facing east. This image captures that with FAA recommended wingtip separations and safety clearances surrounding parked aircraft, no more than two jets can park side by side because the apron depth does not provide enough space. The depth of the apron limits the total number of jets that can be parked on there at a given time.

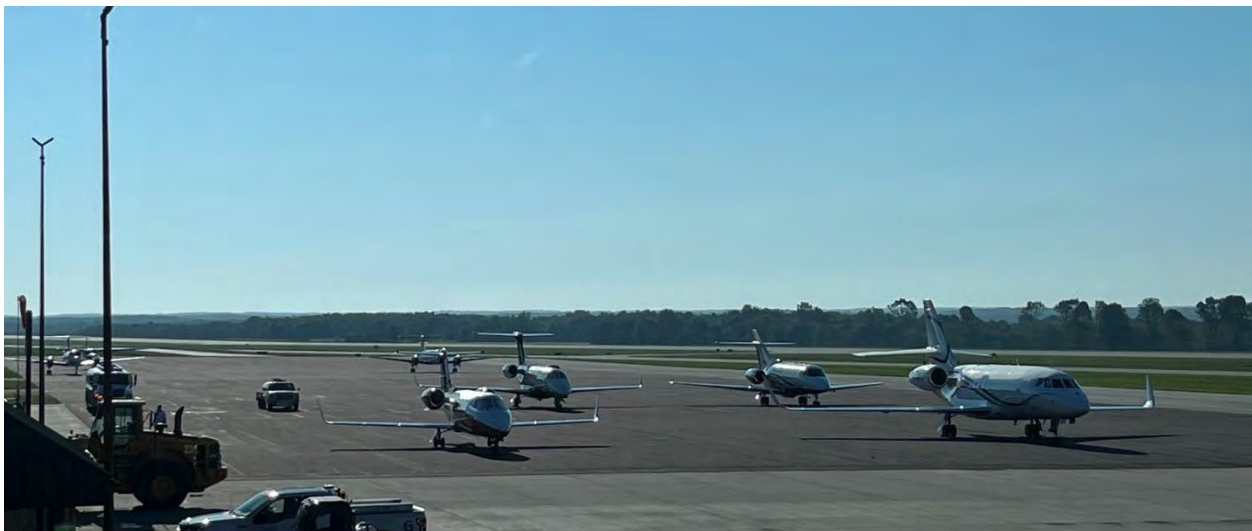
Image 1-6 Jets Parked in Front of FBO Hangar

For orientation, this image was photographed from the passenger terminal and is facing east. This image captures the issue of aircraft parking in a space that interrupts other activity. These jets are parked in front of the west transient hangar. At least two of these aircraft would need to be moved if an aircraft needed to get in or out of the hangar.

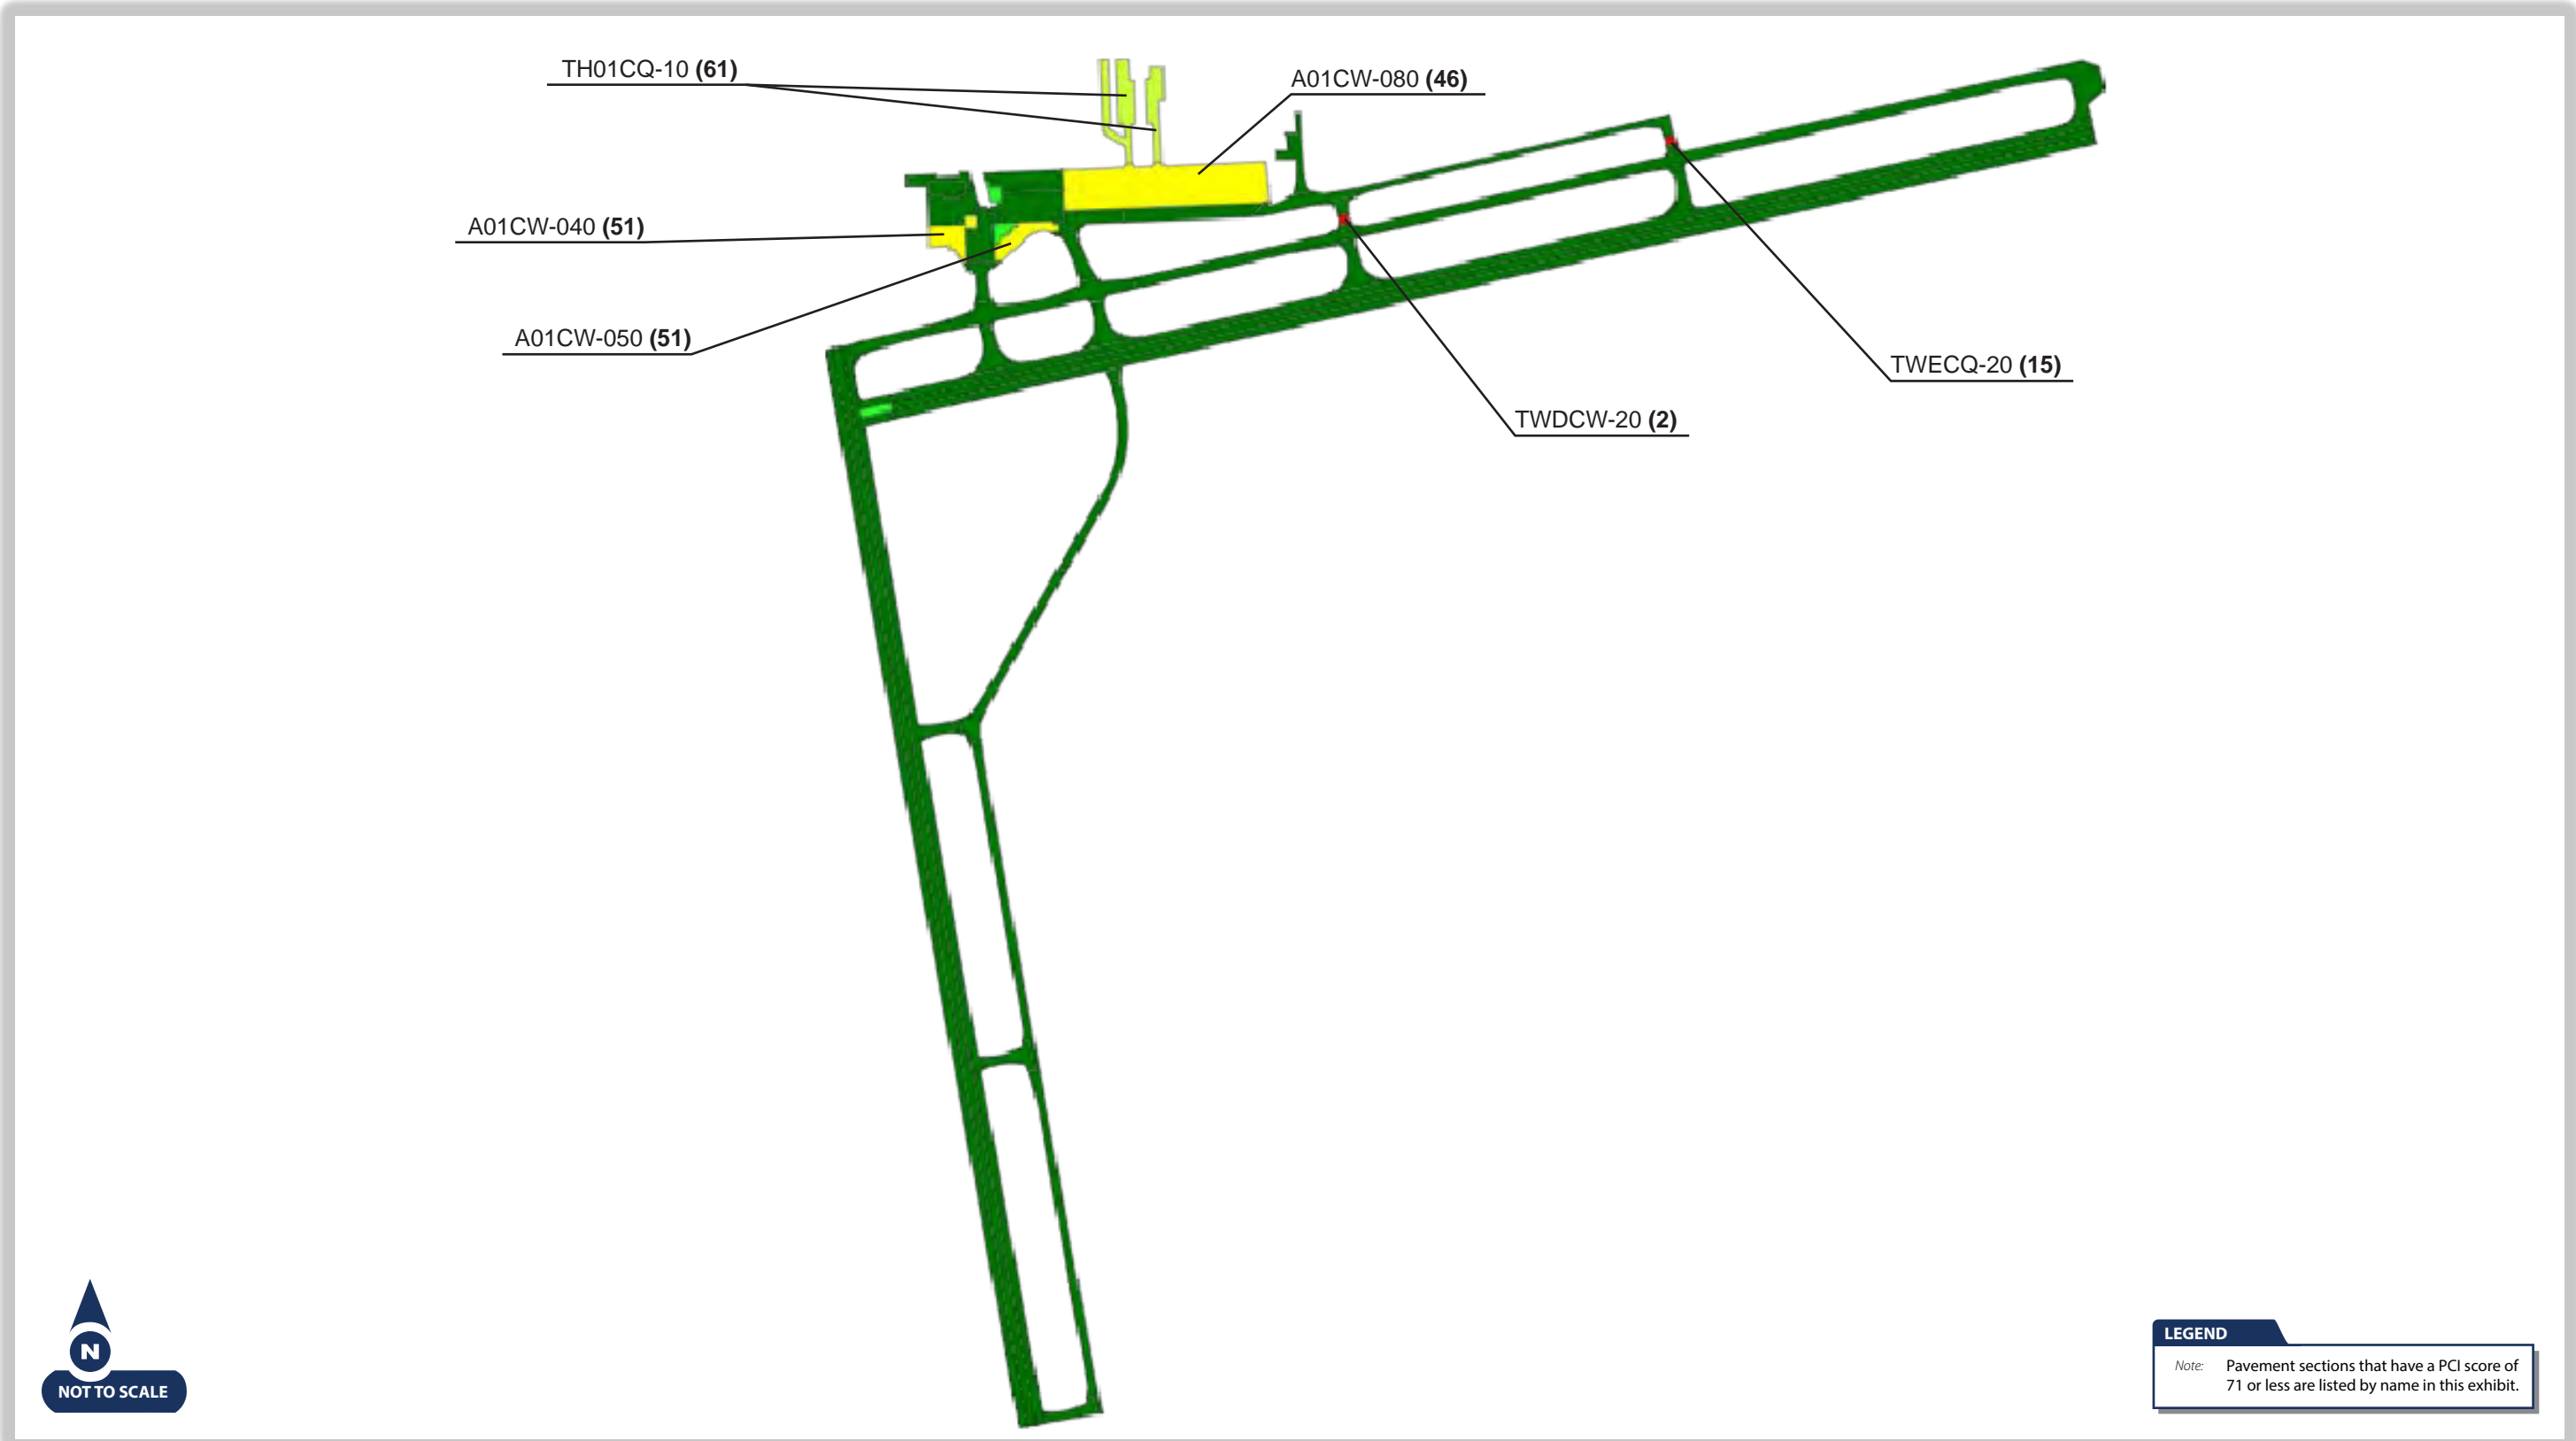
According to a 2021 Pavement Condition Report, completed by Applied Pavement, the Airport has an overall PCI of 93. Most sections of pavement at the airport are in good condition; however, there are a few sections of pavement that are in fair to poor condition.

Both Runway 8/26 and Runway 17/35 are in good condition. Taxiways A, B, and C are all in good condition. Taxiway D and Taxiway E are generally in good condition, but the report indicates that both have a middle section, connecting to Runway 8/26, in poor condition. The taxiways connecting to the T-Hangars are in fair condition, all three with a PCI of 61.

The air carrier apron is in overall satisfactory condition, with an average PCI of 83. Most panels are in good condition with PCI scores in the mid and upper 90; however, there are two panels on the outer edges of the apron with a PCI of 51, and two panels underneath Gates 2 and 4 with scores of 76 and 74, respectively.

The asphalt supporting the general aviation apron is in poor condition with a PCI of 46.

This section focuses on the pavement sections that have a PCI score of 70 or less. These sections do not meet satisfactory conditions and therefore require rehabilitation or reconstruction. These sections, along with their recommended maintenance actions, are summarized in **Table 1-15**. Failure to repair these sections will cause further deterioration leading to unsafe conditions for aircraft to park and maneuver.

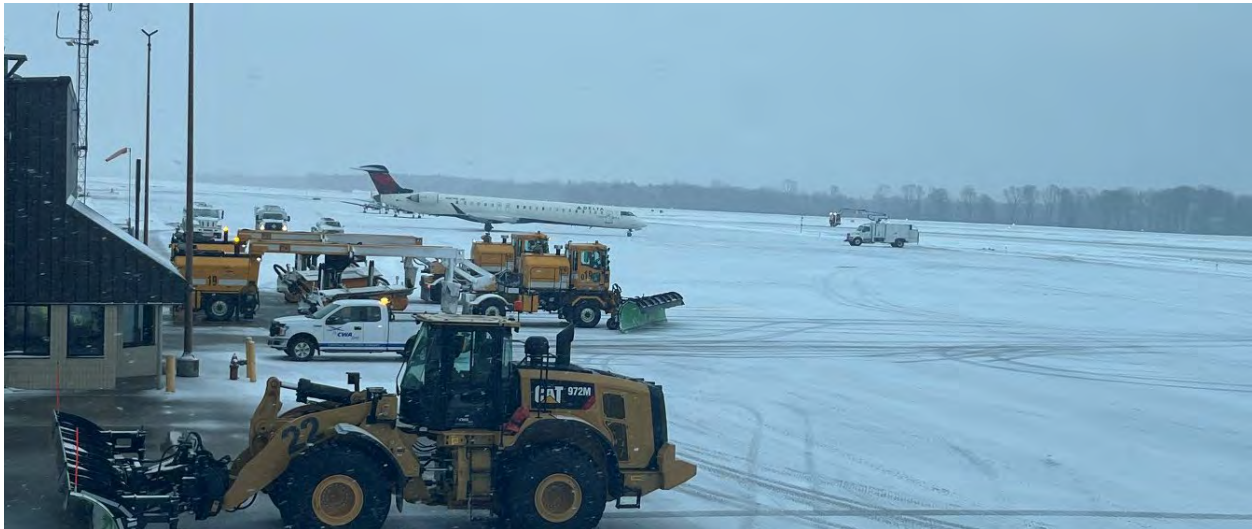
Image 1-10 Deicing Aircraft

For orientation, this image was photographed from the passenger terminal and is facing east. This image captures an aircraft deicing on the GA apron. SRE vehicles are parked outside the ARFF/SRE building which means the aircraft had to be deiced on asphalt. The pavement was not designed to support the loads of commercial service aircraft.
