## DRAFT – INVENTORY AND FACILITY REQUIREMENTS

The purpose of this chapter is to establish existing conditions at the Central Wisconsin Airport (CWA or the Airport) to serve as a baseline for the Terminal Area Master Plan (TAMP or the Master Plan). This chapter will also evaluate the existing facilities to determine their ability to meet forecasted activity and demand as well as Federal Aviation Administration (FAA) design standards. The forecast for TAMP can be found in **Appendix 1**.

CENTRAL WISCONSIN AIRPORT  
MOSINEE, WISCONSIN  
TERMINAL AREA MASTER PLAN

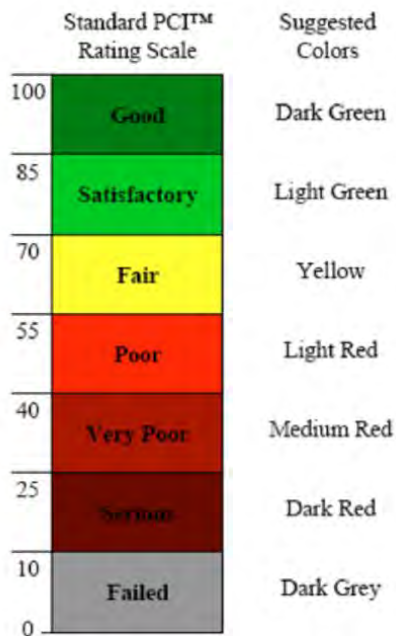
**Figure 1-5: ASTM PCI Rating Scale**

The PCI rating is scored on a scale of 1-100, where, according to the American Society for Testing and Materials (ASTM), a score of 100 indicates the pavement is in good condition, a score of 70 indicates the pavement is in fair condition, and a score of 55 or less indicates the pavement is in poor condition. The scale is further broken down into the following categories:
